SERVICE INFORMATION LETTER

Clarification on the Engine Isolator Inspection Criteria

LM-827-SA2, -SA7, -SA10, -SA11

LM827-71-001

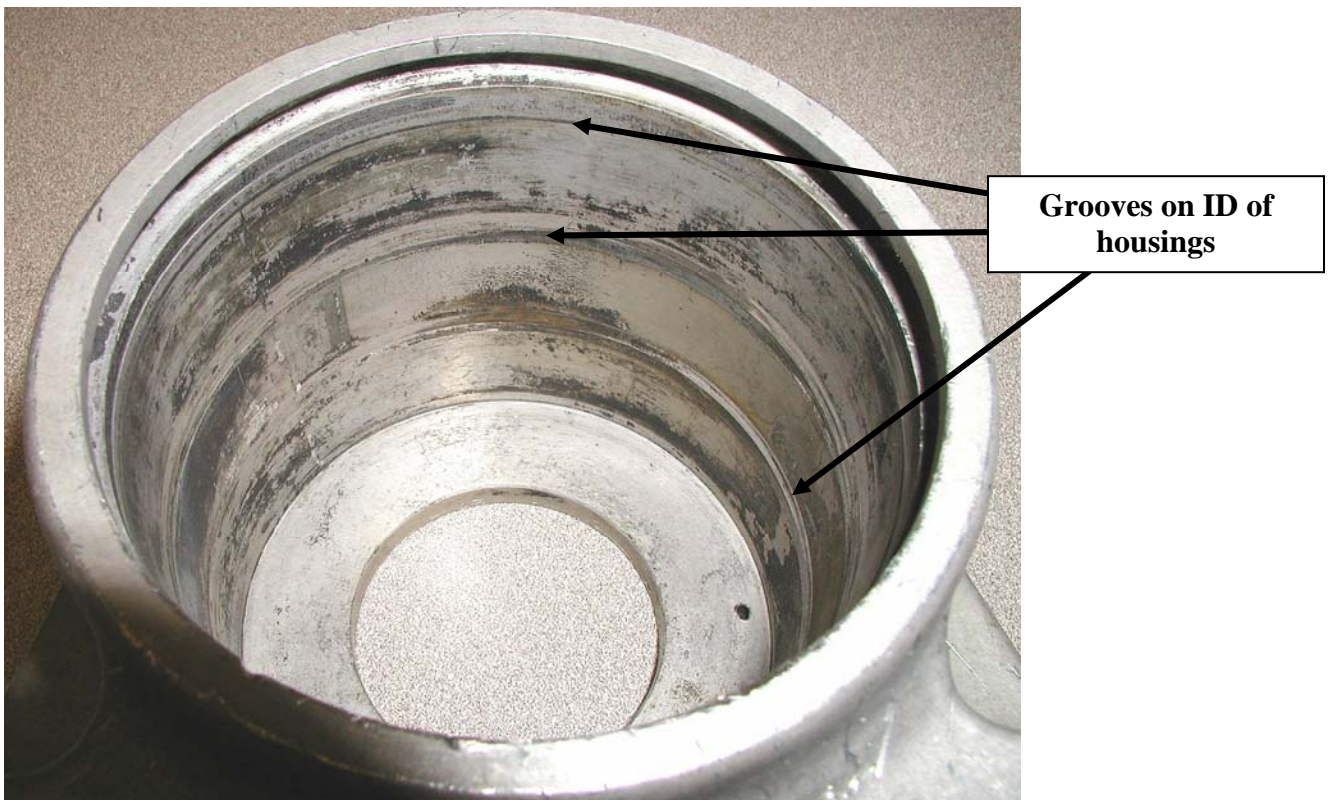
FIGURE 1

1. It has come to Lord Corporation's attention that the housings for the LM-827-SA2, -SA7, -SA10 and -SA11 have some excessive wear and damage both on the exterior of the housing and the inner diameter. The CMM is somewhat vague for these parts and this service letter will clarify the inspections.
2. With time, wear takes place between the rubber sandwiches and the inner diameter of the housing resulting in grooves in the housing as shown in Figure 1.

3. These grooves should be machined out locally (the entire ID of the housing does not have to be machined, just where the groove has formed) with 64 micro-inches maximum surface finish with a minimum transition radius of .075 inches (no sharp edges). The maximum inner diameter is as follows:

- The inner diameter for the LM-827-SA10 housing, LM-827-46, should have a maximum diameter of 3.617 inches. If this value is exceeded, the part should be replaced.

- The inner diameter for the LM-827-SA11 housing, LM-827-45, should have a maximum diameter of 3.077 inches. If this value is exceeded, the part should be replaced.

- The inner diameter for the LM-827-SA2 housing, LM-827-15, should have a maximum diameter of 3.077 inches. If this value is exceeded, the part should be replaced.

- The inner diameter for the LM-827-SA7 housing, LM-827-35, should have a maximum diameter of 3.077 inches. If this value is exceeded, the part should be replaced.

- If there remains some local wear or damage to the inner diameter after machining, it is acceptable to polish this area (to a 64 micro-inches maximum surface finish with .075 inch minimum radius) if the area is less than an inch long and does not exceed .030 inches deep from the original surface prior to machining the inner diameter. If this is exceeded, replace the part.

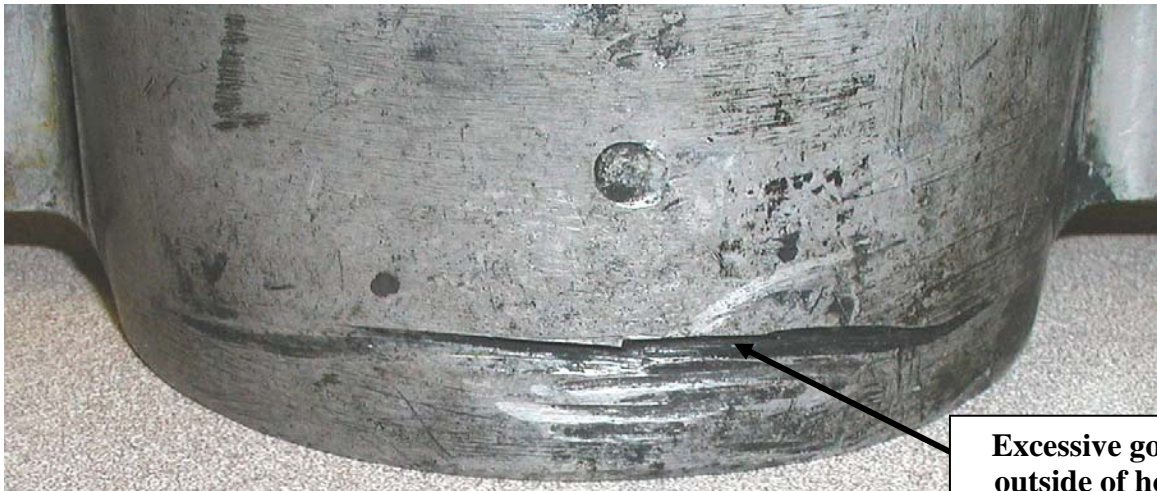
Figure 2

4. The exterior of the some of the returned housings have had some gouges / scratches as shown in Figure 2.

**Excessive gouge to
outside of housing**

If a gouge or scratch exceeds .03 inches deep from the original surface, replace the housing. If less than .03 inches deep and less than 1 inch long, blend the area with 64 micro-inches maximum surface finish with .075 inch minimum radius.

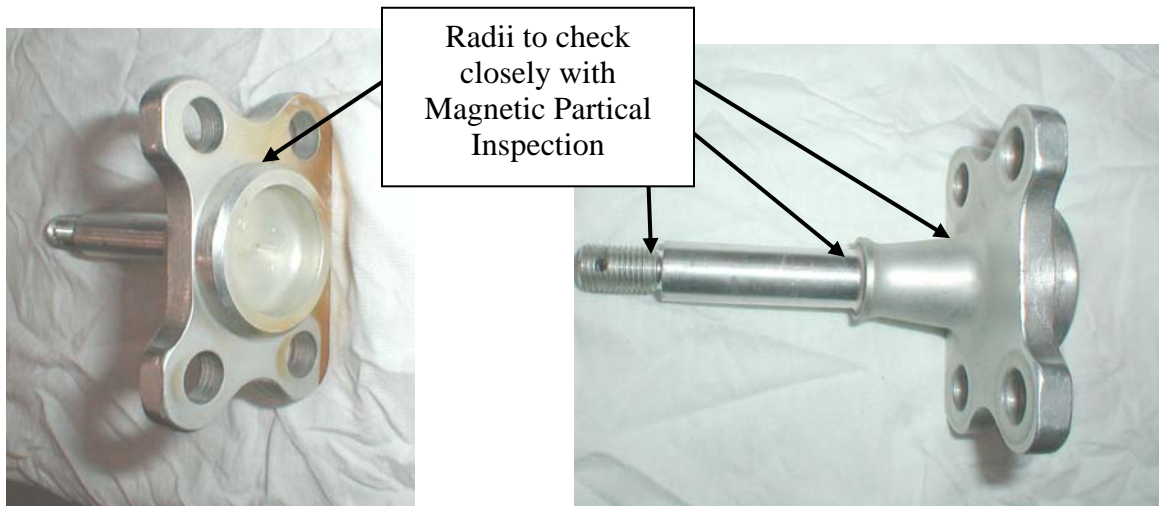
Figure 4

6. If there is any machining or polishing or wear that exposes the bare material on the housings, anodized per MIL-A-8625, Type I, Class 1, Dichromate Seal.
7. These housing must be penetrant inspected per the CMM.
8. The stem brackets LM-827-2 and LM-827-39 should be non-destructive tested (NDT) per the CMM for cracks with special review of the radii as shown in Figure 4. If any cracks are found, replace the part. No nicks or gouges are allowed in these radii.

Other areas of the part can have nicks or gouges to a maximum depth of .02 inches from the original surface and no longer than .25 inches. These areas must be blended out with 64 micro-inches maximum surface finish with .075 inch minimum radius. Blended areas must be Cadmium plated per QQ-P-416, Class 3, Type II
